NEW RIVER DAM FOUNDATION REPORT GILA RIVER BASIN:
PHOENIX ARIZONA AND VICINITY (INCLUDING NEW RIVER) (U)
ARMY ENGINEER DISTRICT LOS ANGELES CA OCT 85

New River Dam Foundation Report

October 1985

20. ABSTRACT (Continue on reverse side if necessary and identify by block number) This report provides a complete and accurate record of foundation conditions underlying New River Dam and its appurtenances. The report also summarizes construction methods employed in excavating, preparing and treating the foundations; describes testing and explorations performed during construction and design modifications required by unforeseen site conditions; and discusses conditions which may require post-construction observation or treatment. Includes 64 plates.

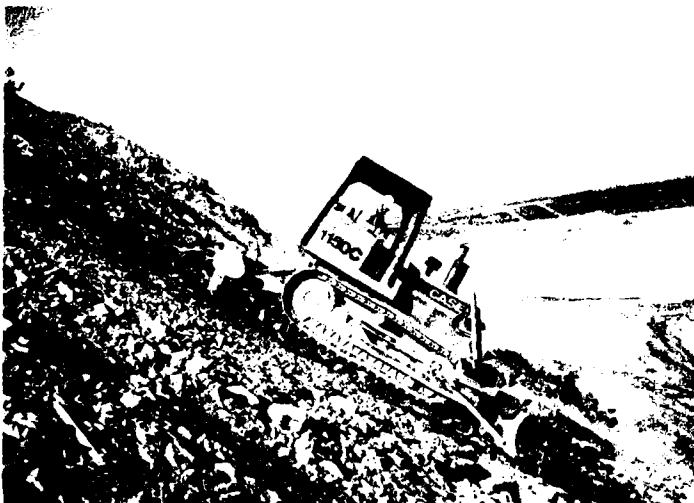
Photo 42. Case 1150C dozer ripping right abutment with
double shank ripper teeth; note double parted winch cable.
6 December 1983

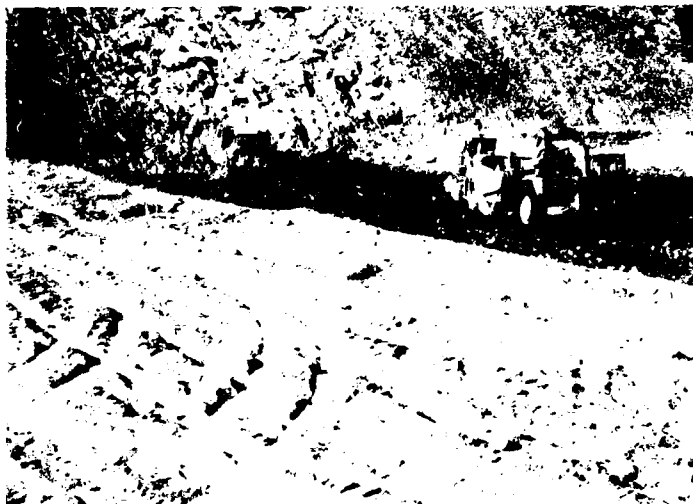
Photo 44. Stage I core trench excavation using push cat and scraper. Note D8 dozer using rippers and blade to excavate base of right abutment. 16 December 1983

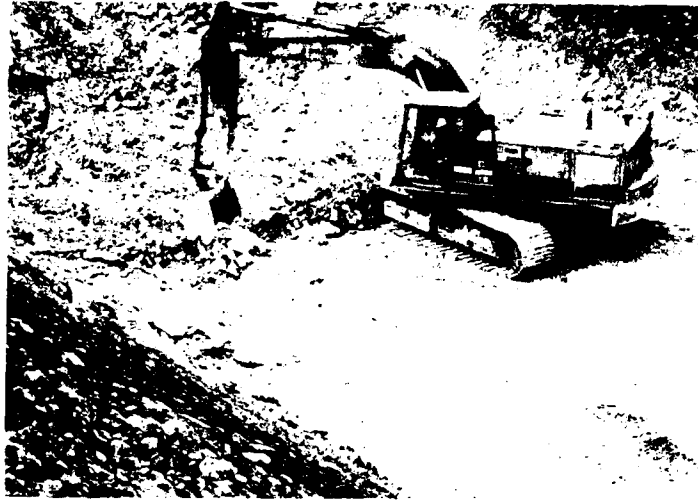
Photo 45. Excavating andesite bedrock in Stage I core trench using Caterpillar 235 excavator, vicinity station 31+10. 22 December 1983

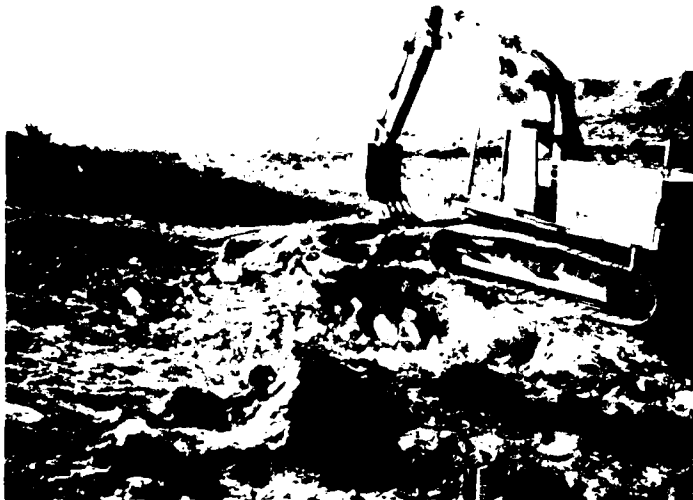
Photo 47. Left abutment excavation using 235 excavator.
January 1984

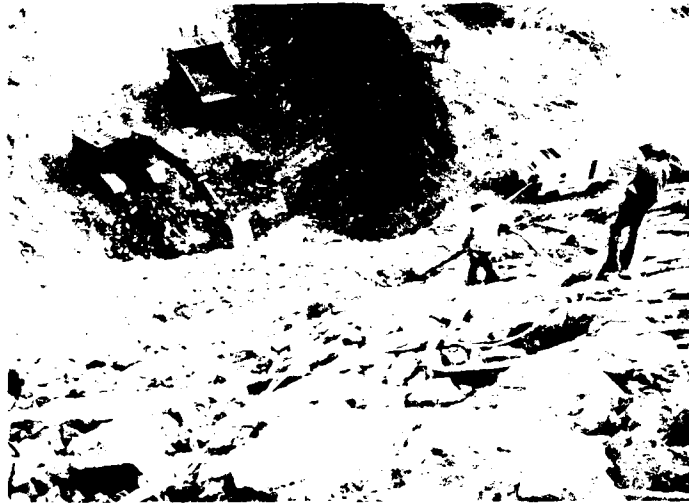
Photo 51. Foundation preparation of right abutment surface using high pressure air blasting. Note excavator working on south side of Stage I core trench. 21 December 1983

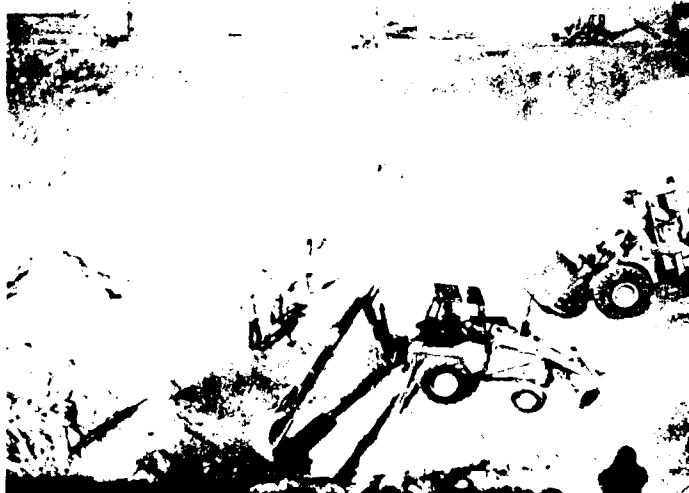
Photo 52. Foundation preparation of Stage I core trench surface using backhoe and hand labor, vicinity station 30+00. Note darker colored rock is agglomerate cap. 6 January 1984

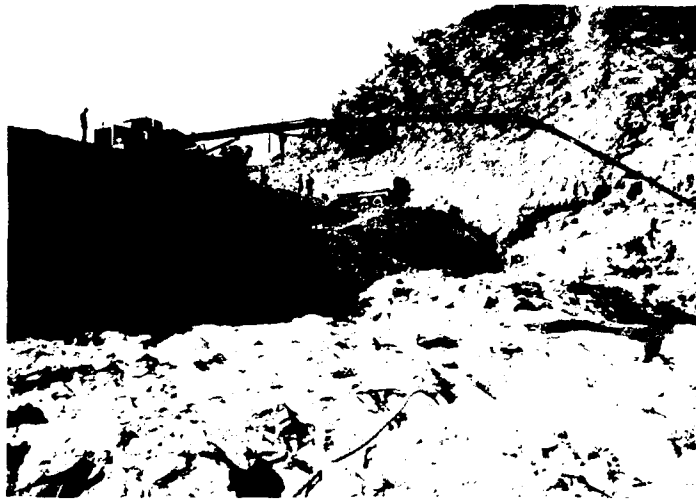
Photo 53. Pump truck with extendable boom and hose used for dental concrete placement in Stage I core trench. 10 February 1984

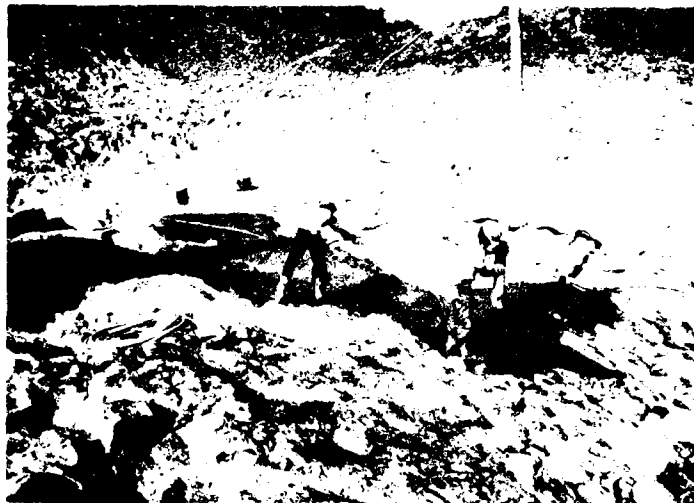
Photo 54. Placing and vibrating dental concrete in Stage I core trench. 10 February 1984

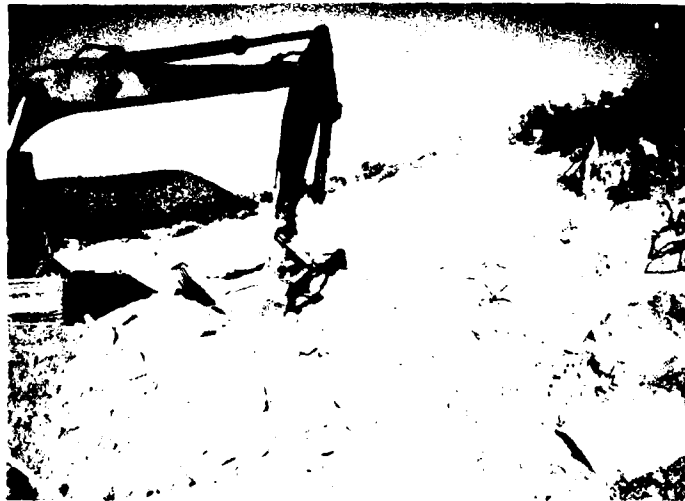
Photo 63. Initial foundation preparation of left abutment surface using low pressure air blasting. Note 235 excavator on left. 6 January 1984

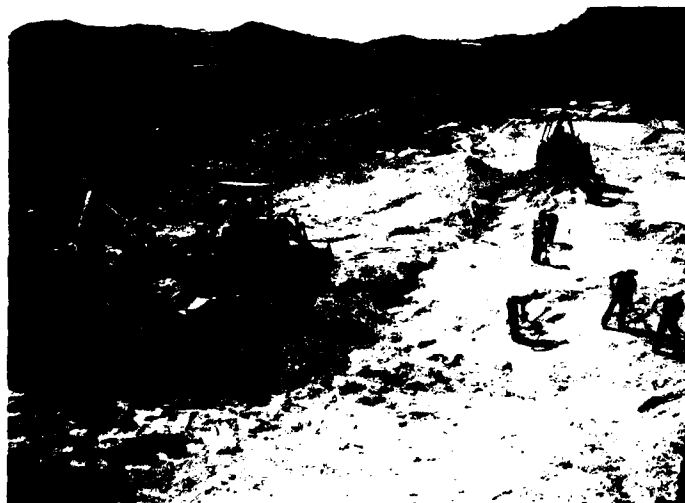
Photo 64. Foundation preparation in Stage II core trench using backhoes and shovels; vicinity station 17+00. 12 March 1984

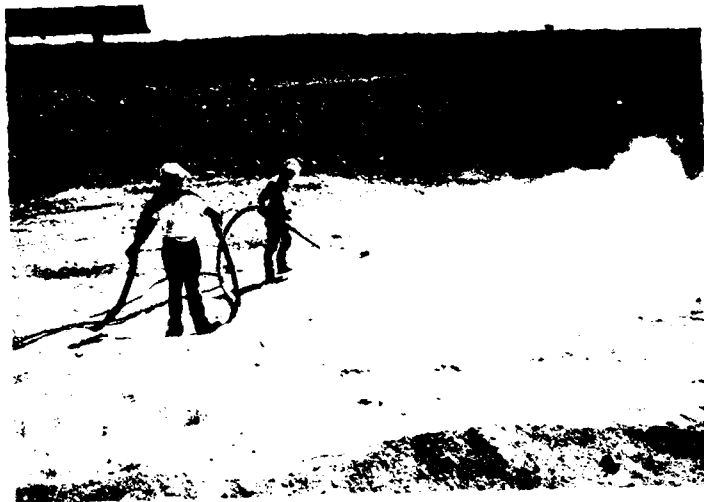
Photo 65. Air cleaning core trench surface at station 20+80 using high pressure bull hose. 16 March 1984

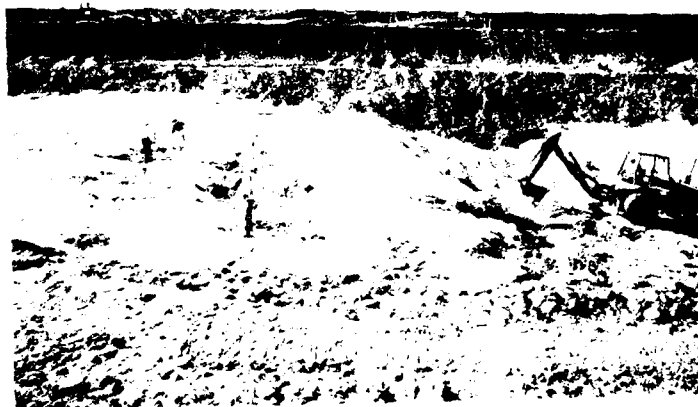
Photo 66. Stage II core trench foundation preparation. Laborers removing alluvial materials loosened by backhoe from bedrock scour channels. 26 March 1984

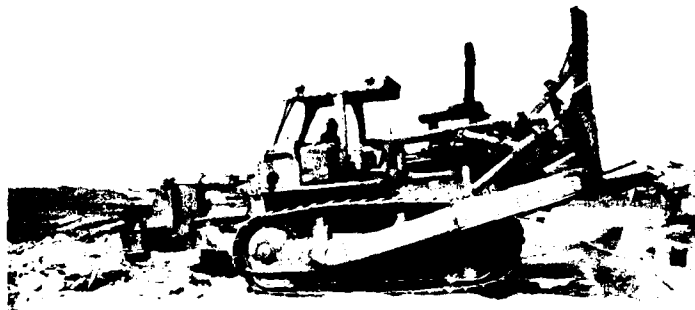
Photo 67. D9H dozer with double shank ripping calichified granite cap at the upstream edge of the core trench, vicinity station 16+30. 12 March 1984

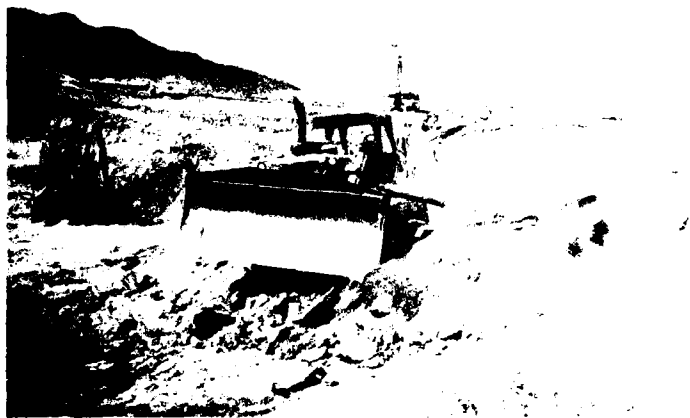
Photo 68. D9H dozer using slopeboard to flatten bedrock slope near station 16+50 to 1:1 and remove soft weathered bedrock from foundation surface. 12 March 1984

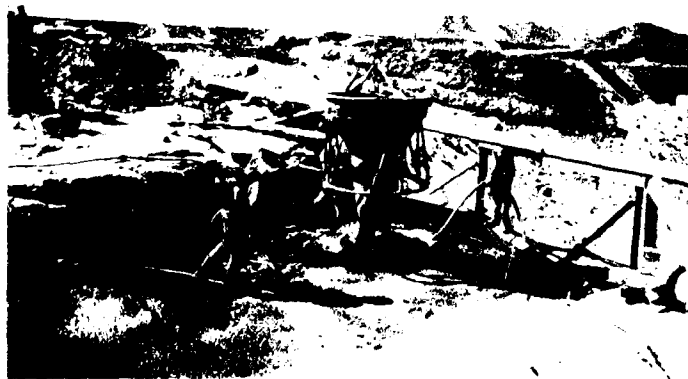
Photo 72. Backfilling preconstruction test trench between stations 16+00 and 16+50, downstream side of core trench, with dental concrete. Note sloping bulkhead constructed across open end of trench to contain concrete. 30 March 1984

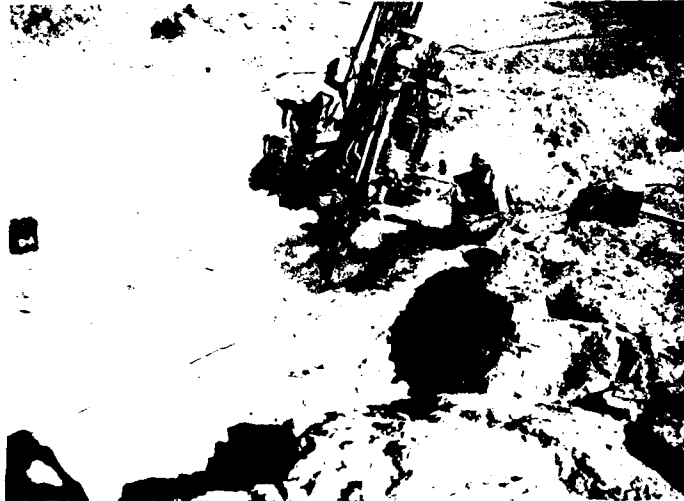
Photo 73. Drilling first zone of primary grout hole 30+00P using air track percussion drill. Air-water mixture used as circulating medium. 10 January 1984

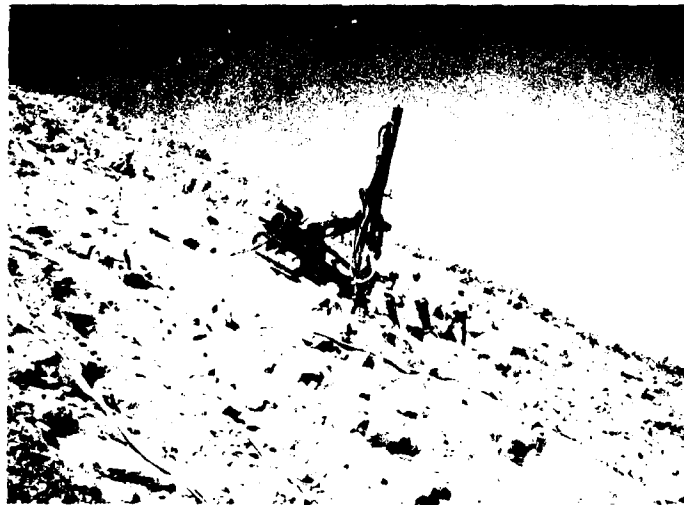
Photo 74. Air track drilling first zone of secondary grout hole 32+34S on right abutment slope. Drill pulled up slope using winch cable system. 6 March 1984

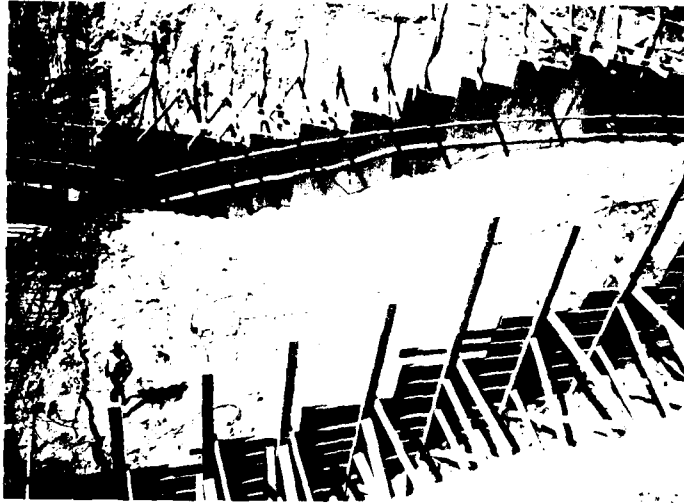
Photo 77. Overexcavated energy dissipator slope. Note chamfer lines on bulkhead. Bottom line is top of dental concrete or "B" line elevation while top line is invert of structural concrete. 19 March 1984

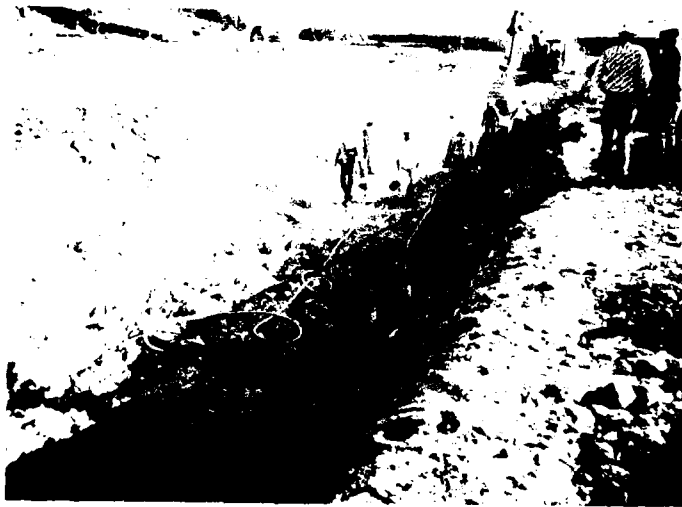
Photo 78. 235 excavator scraping off loosened rock from surface of outlet conduit trench. Note relatively level surface (where laborers are walking). 16 January 1984

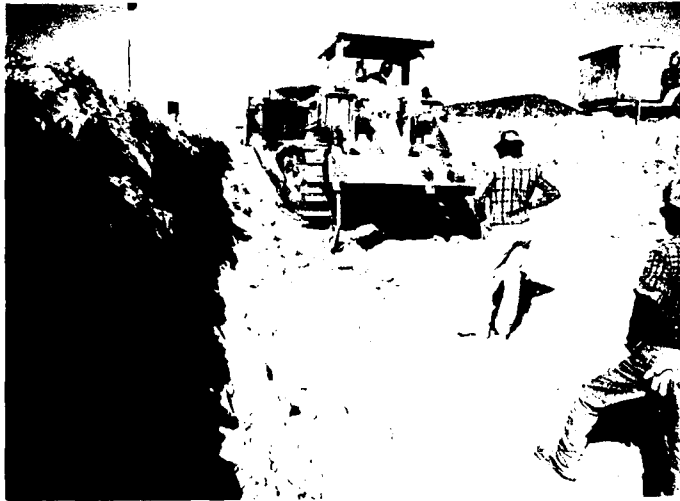
Photo 79. D9 dozer ripping high spot at station 19+70 in outlet conduit trench excavation. 17 January 1984

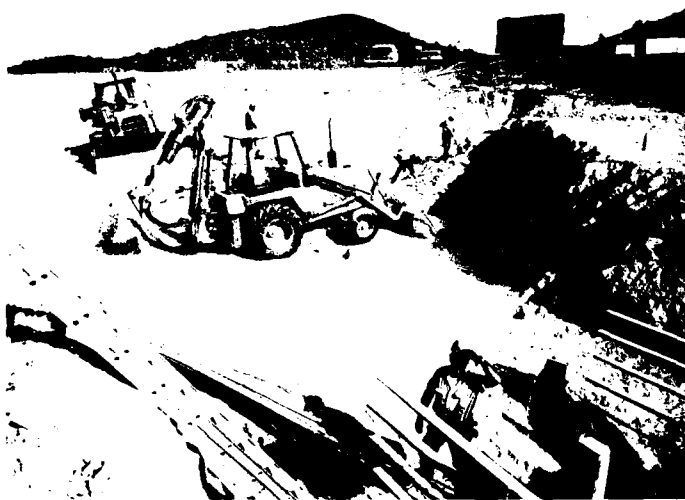
Photo 80. Intake structure foundation preparation. Note laborer jackhammering high spots on left (east) side wing wall steps down to grade. 1 February 1984

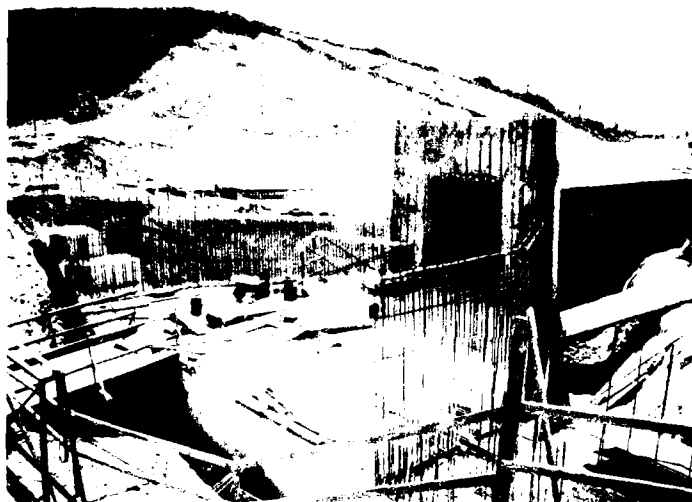
Photo 81. Partially completed outlet works intake structure.
Note overexcavated area upstream of invert concrete slab.
26 March 1984

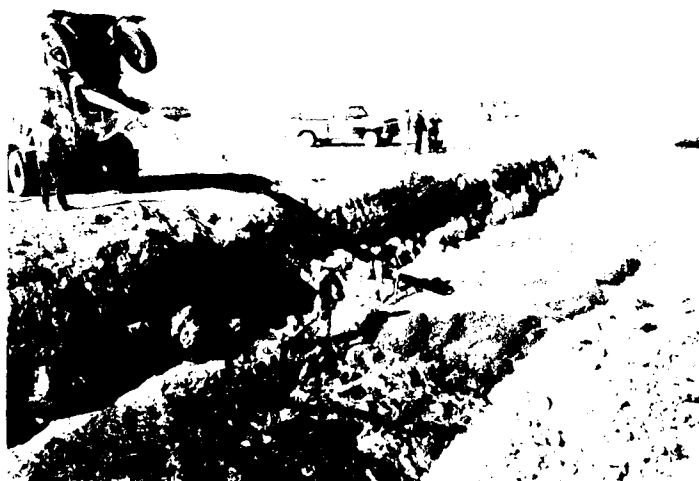
Photo 86. Placing leveling slab of dental concrete in outlet conduit excavation. Wooden screed bar used for leveling surface of slab. 24 January 1984

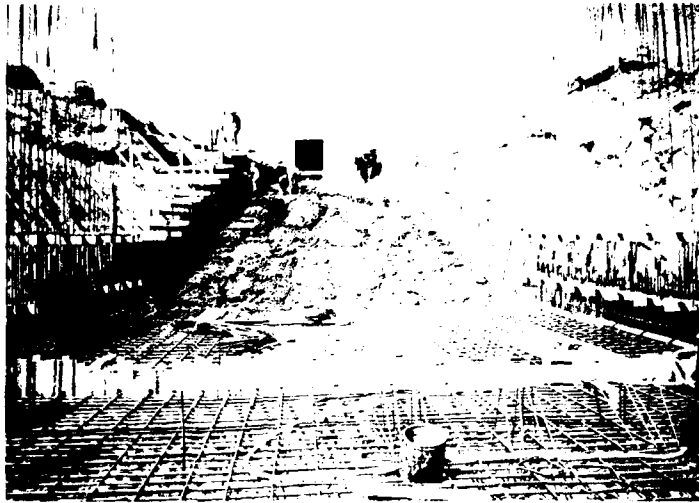
Photo 87. Looking upstream at dental concrete placement on energy dissipator slope. 20 March 1984

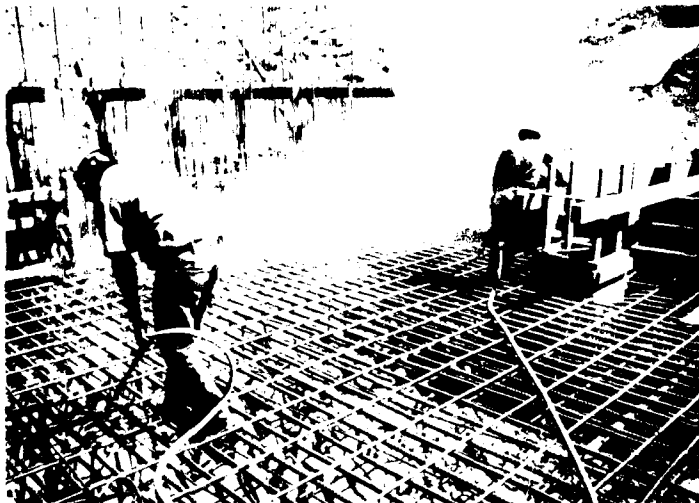
Photo 88. Final cleanup of energy dissipator foundation by low pressure air blasting. 20 March 1984

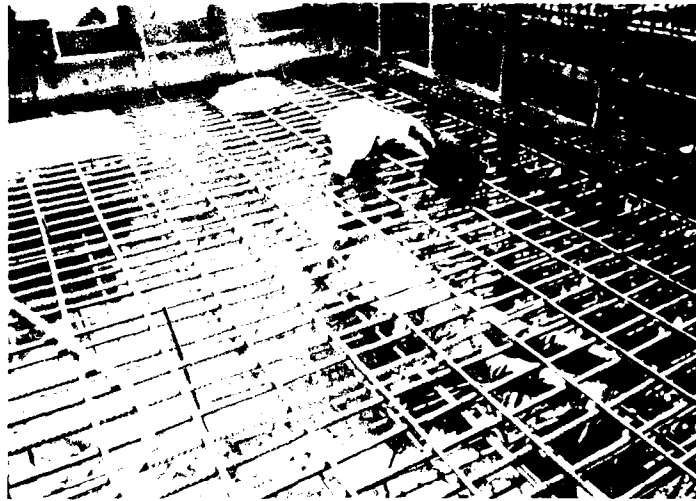
Photo 89. Hand picking loose rock from foundation surface underneath energy dissipator rebar lattice. 20 March 1984

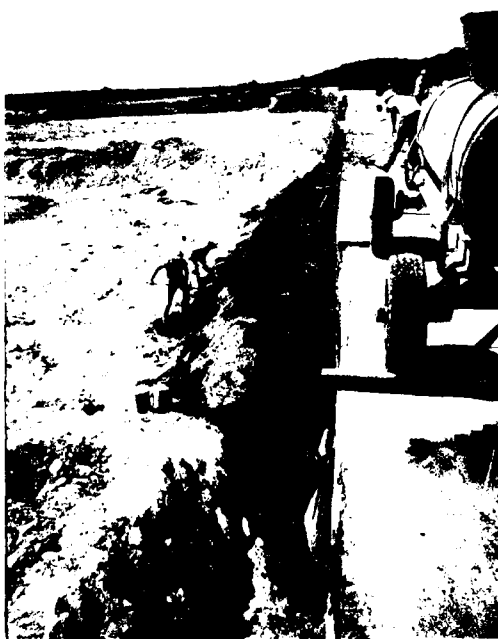
Photo 92. Concrete plug on west side of outlet conduit. Note upper portion of plug is slightly steeper than 1:1 to eliminate "feather" edges against the top of the conduit. 25 April 1984

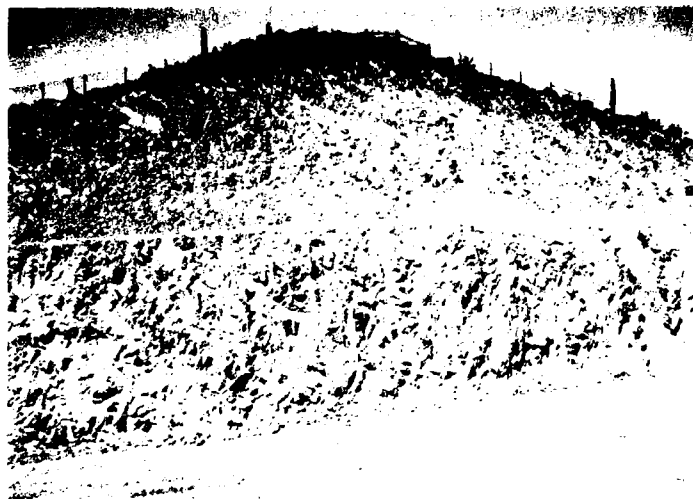
Photo 95. Typical example of strongly jointed andesite flow exposed in north wall of spillway excavation, vicinity station 17+00. Note variable joint patterns and darker colored "zone of weathering" near surface of flow.
20 March 1985

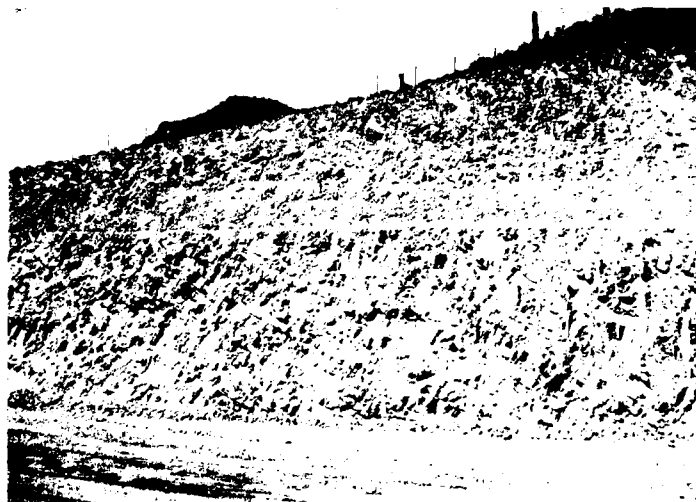
Photo 96. Strong subparallel to wedge shaped joint pattern (striking $N75^{\circ}E$, dipping $45^{\circ}NW$) exposed in north wall of spillway excavation below bench, vicinity station 15+50.
20 March 1985

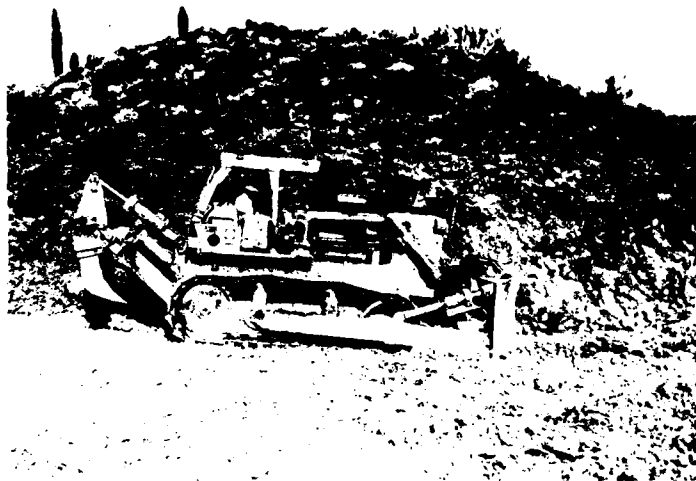
Photo 97. Mechanical excavation in spillway using D9H dozer with double shank. Note slopeboard used for slope trimming. 27 October 1983

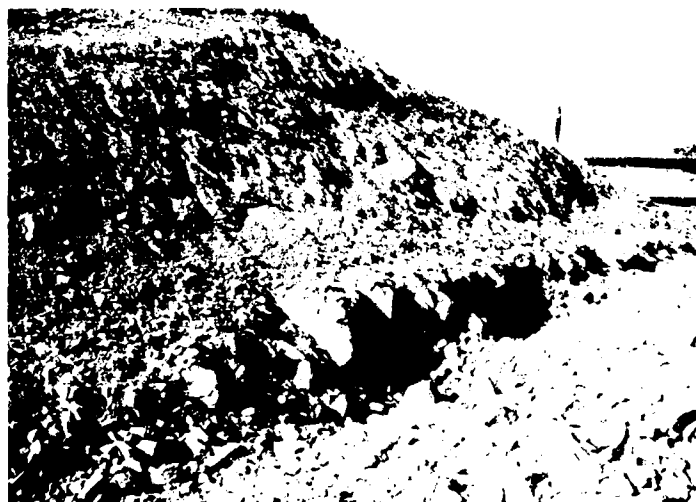
Photo 98. North side of spillway excavation after production shot No. 9 down to bench excavation. Note 1 to 2-foot buffer of rock left by step-drilling blasting technique which was subsequently removed to grade using dozer slopeboard. 9 March 1984

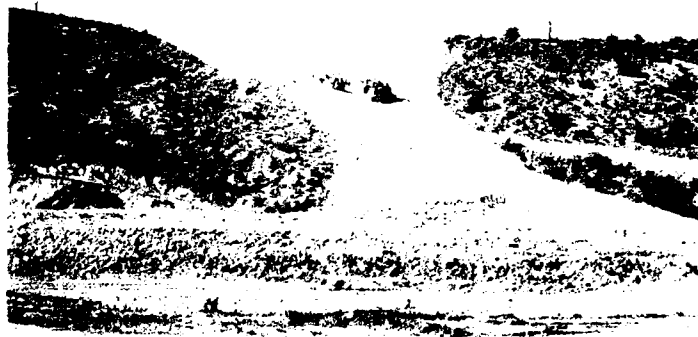
Photo 100. Scraper hauling shot rock from spillway for Stage II diversion levee slope protection. Dozer with slopeboard used for slope trimming. 22 March 1984

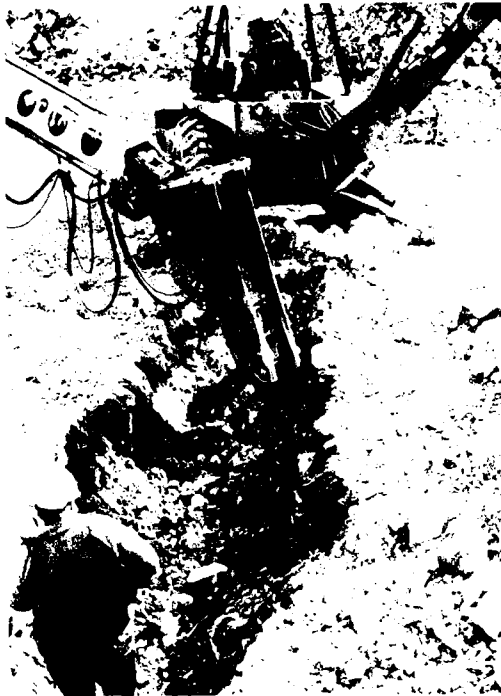
Photo 103. Excavating spillway sill at station 17+50 using a Gradall with hydraulic ram attachment to break up the rock, and a Case backhoe to excavate the broken rock.
28 November 1984

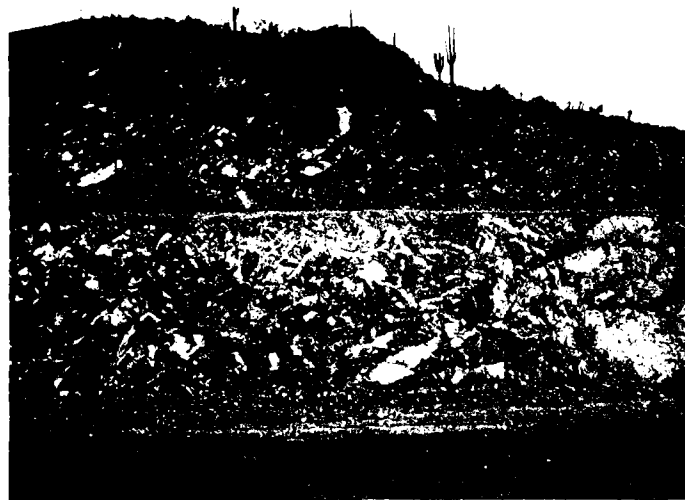
rock, resulting in an average PF of about 0.75. In the final analysis, the step-drilling and trim blast techniques employed produced acceptable results considering the diverse geologic conditions (photo 107). The variability in the excavation characteristics of the spillway rocks produced an end-product excavation which locally deviates from original lines and grades. Rockfalls which occurred during and after excavation have reduced bench widths from the specified 12 feet to as little as 6 feet in some areas (photo 108). These rockfalls may have been induced by blasting effects but more likely the presence of loosely keyed rock blocks and dip-slope joint planes precipitated slope failures. The side slopes appear to have stabilized, although minor raveling and sloughing will probably continue to occur. This may require periodic maintenance cleaning of the benches and invert section.

Photo 107. South wall of completed spillway excavation, vicinity station 16+00. Note variable joint orientations and spacings, including prominent dip-slope joint planes. 18 April 1985

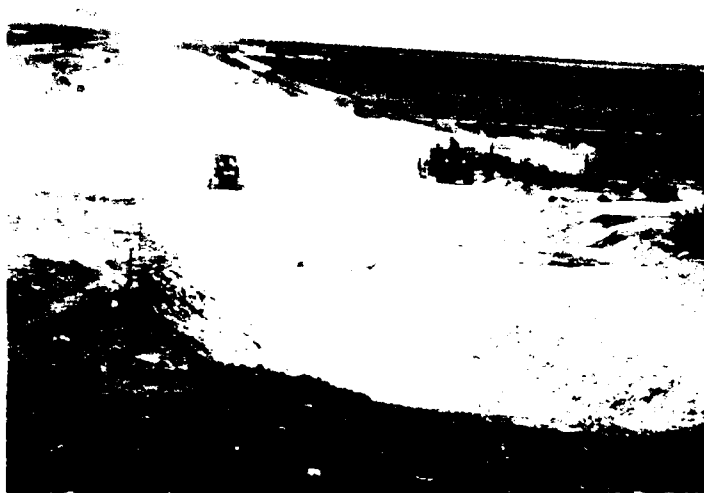
4.170 After stripping was completed, an exploration trench was excavated beneath the core zone (photo 110) to an average depth of 5 feet or sound bedrock as shown on plates 53 through 55. Only about 8 percent of the excavation was in bedrock with the remainder being in caliche (photo 111). The exploration trench was ripped with D9 dozers and then excavated with push dozers and scrapers. Removal of approximately 2 to 9 feet of andesite rock was required to reach a suitable foundation surface. An overall greater depth of excavation was required in the weathered portion of the andesite flow near the downstream end. The caliche or hardpan layer was so well indurated in some reaches that the dozer was unable to reach the designated depth and as a result hard humps were left in the bottom of the trench.

Photo 110. View of dike No. 1 exploration trench excavation
looking north from south abutment. January 1984

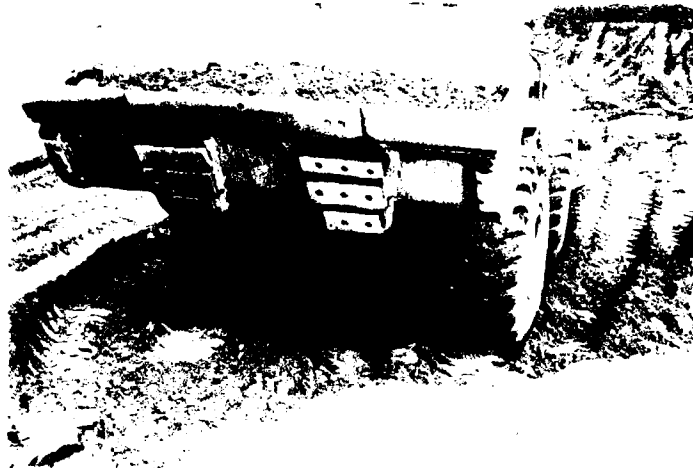
Photo 113. Front end loader with full bucket compacting initial lift of core material against treated bedrock surface in Stage I core trench, vicinity station 30+70. 13 February 1984

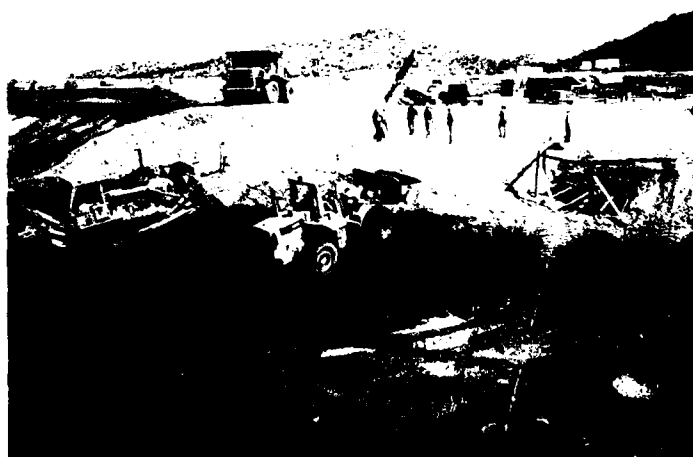
Photo 114. Front end loader compacting core material against bedrock slope in Stage II core trench, vicinity station 16+50. Note dozer using blade to spread core material over foundation surface. 2 April 1984
